FT1000MK-V Field Main RX signal disappears, restored when Main VFO knob moved**Author:** Ian Benjamin - VE9HB**FT1000MK-V Field Main RX signal disappears, restored when Main VFO knob moved**

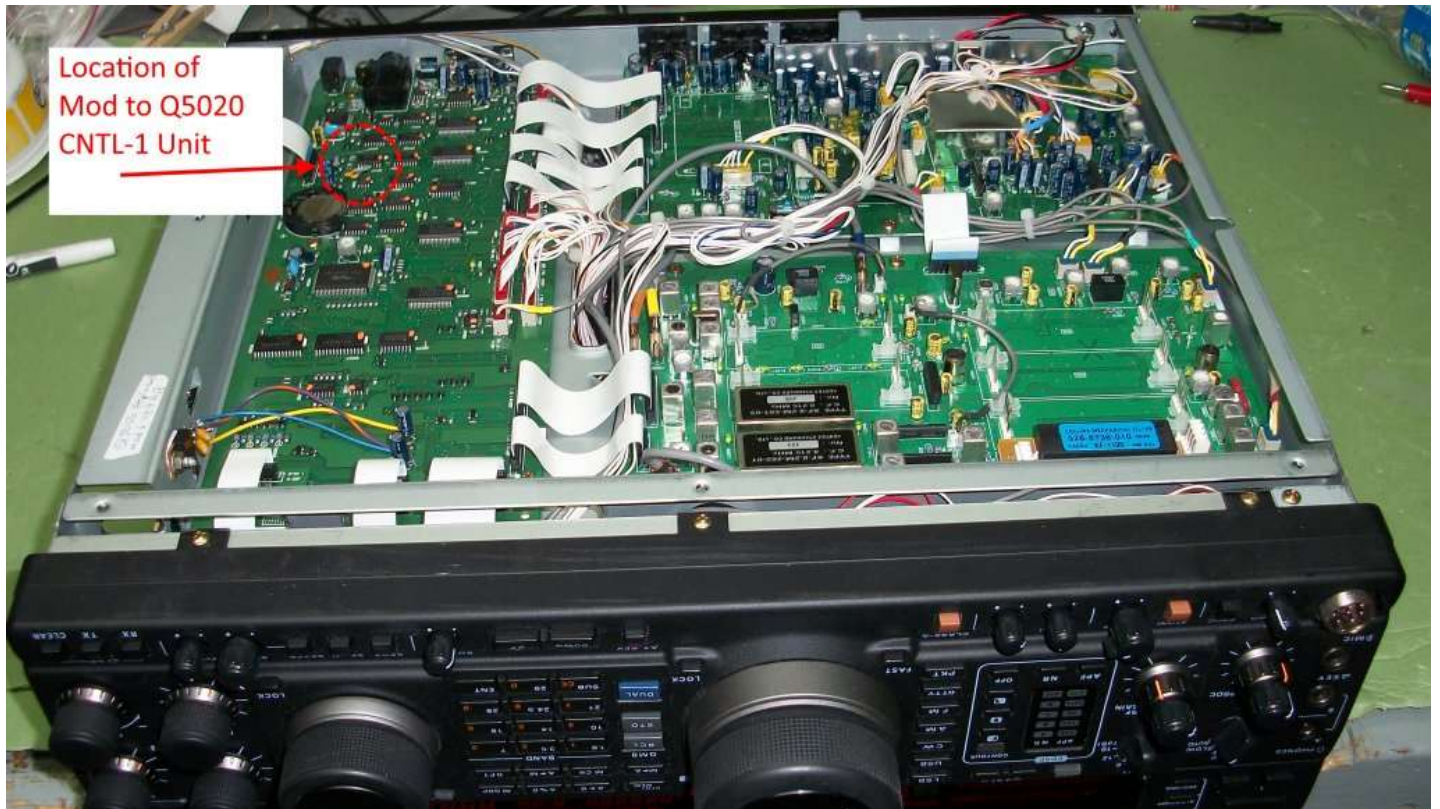
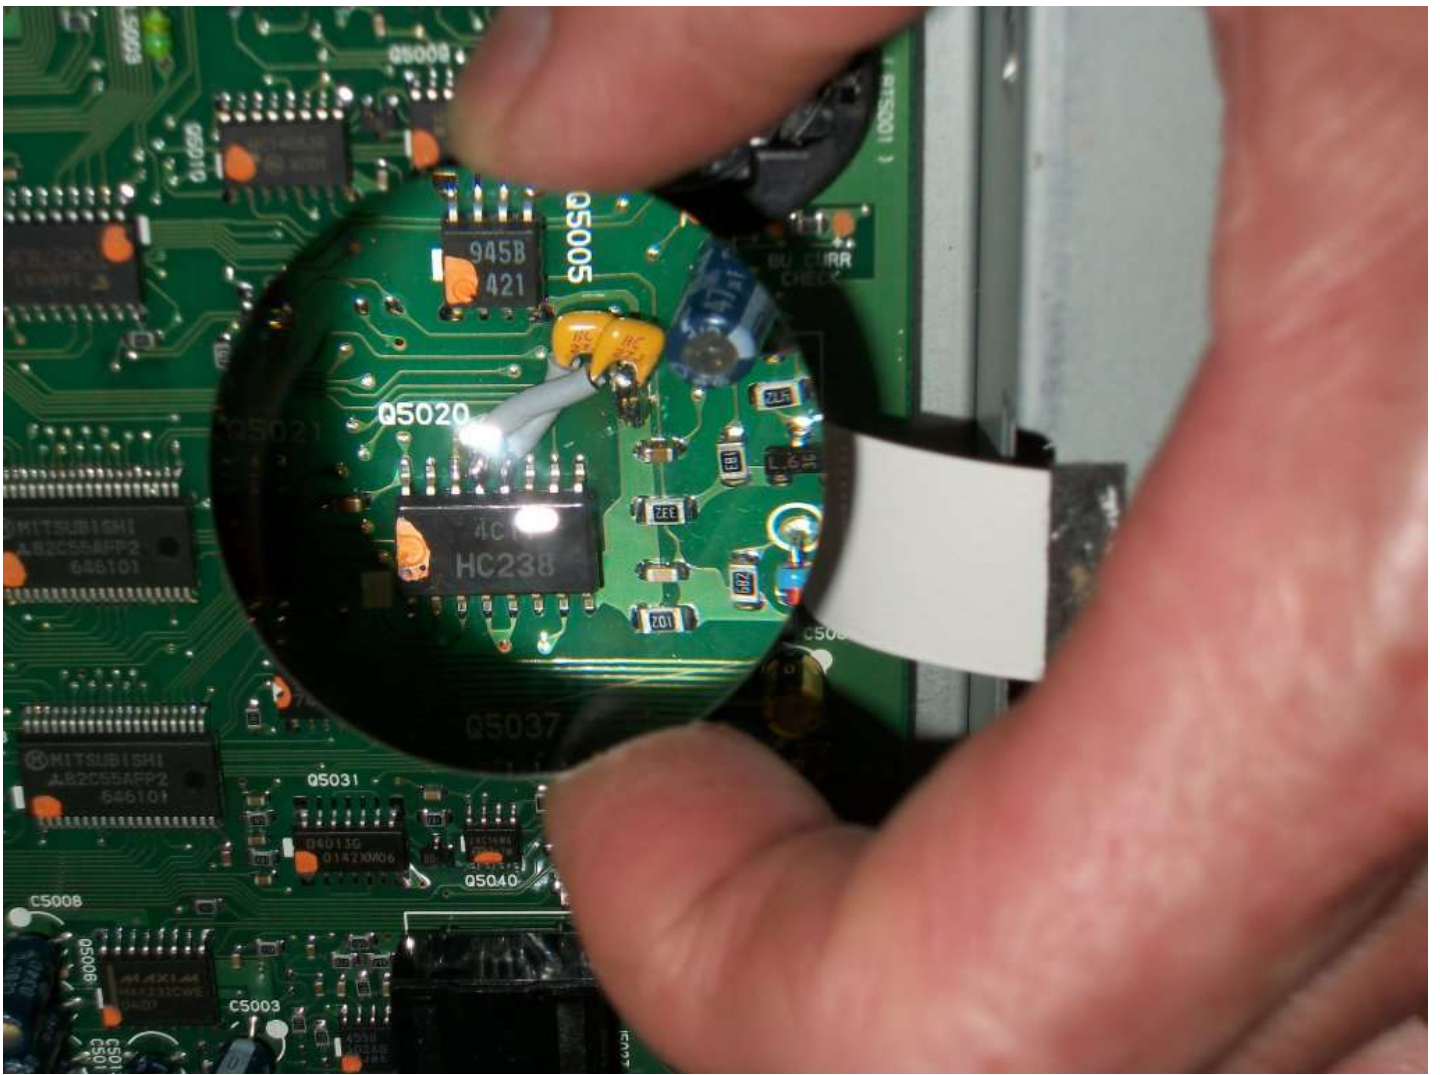
Much troubleshooting!! Found that the PLL-DDS unit was jumping to same frequency as SUB-DDS when fault occurs. Same serial freq. data fed to the 2 units, but 2 different strobe pulses are used at different times to latch the appropriate freq data into the each DDS. Stray capacitance between the wiring, along with $\sim 7\text{nS}$ rise time of trigger pulse suspected of creating crosstalk.

Added 27PF capacitors at Q5020 pins 12,13 to load the ST2, ST3 lines. This loading cuts amount of crosstalk to point where fault vanishes. The strobe generator Q5020 can handle 3X this value of capacitance, so within spec.
